UPPER RESERVOIR DAM

NH 00049

PHASE I INSPECTION REPORT NATIONAL DAM INSPECTION PROGRAM

Date of Inspection: October 26, 1979

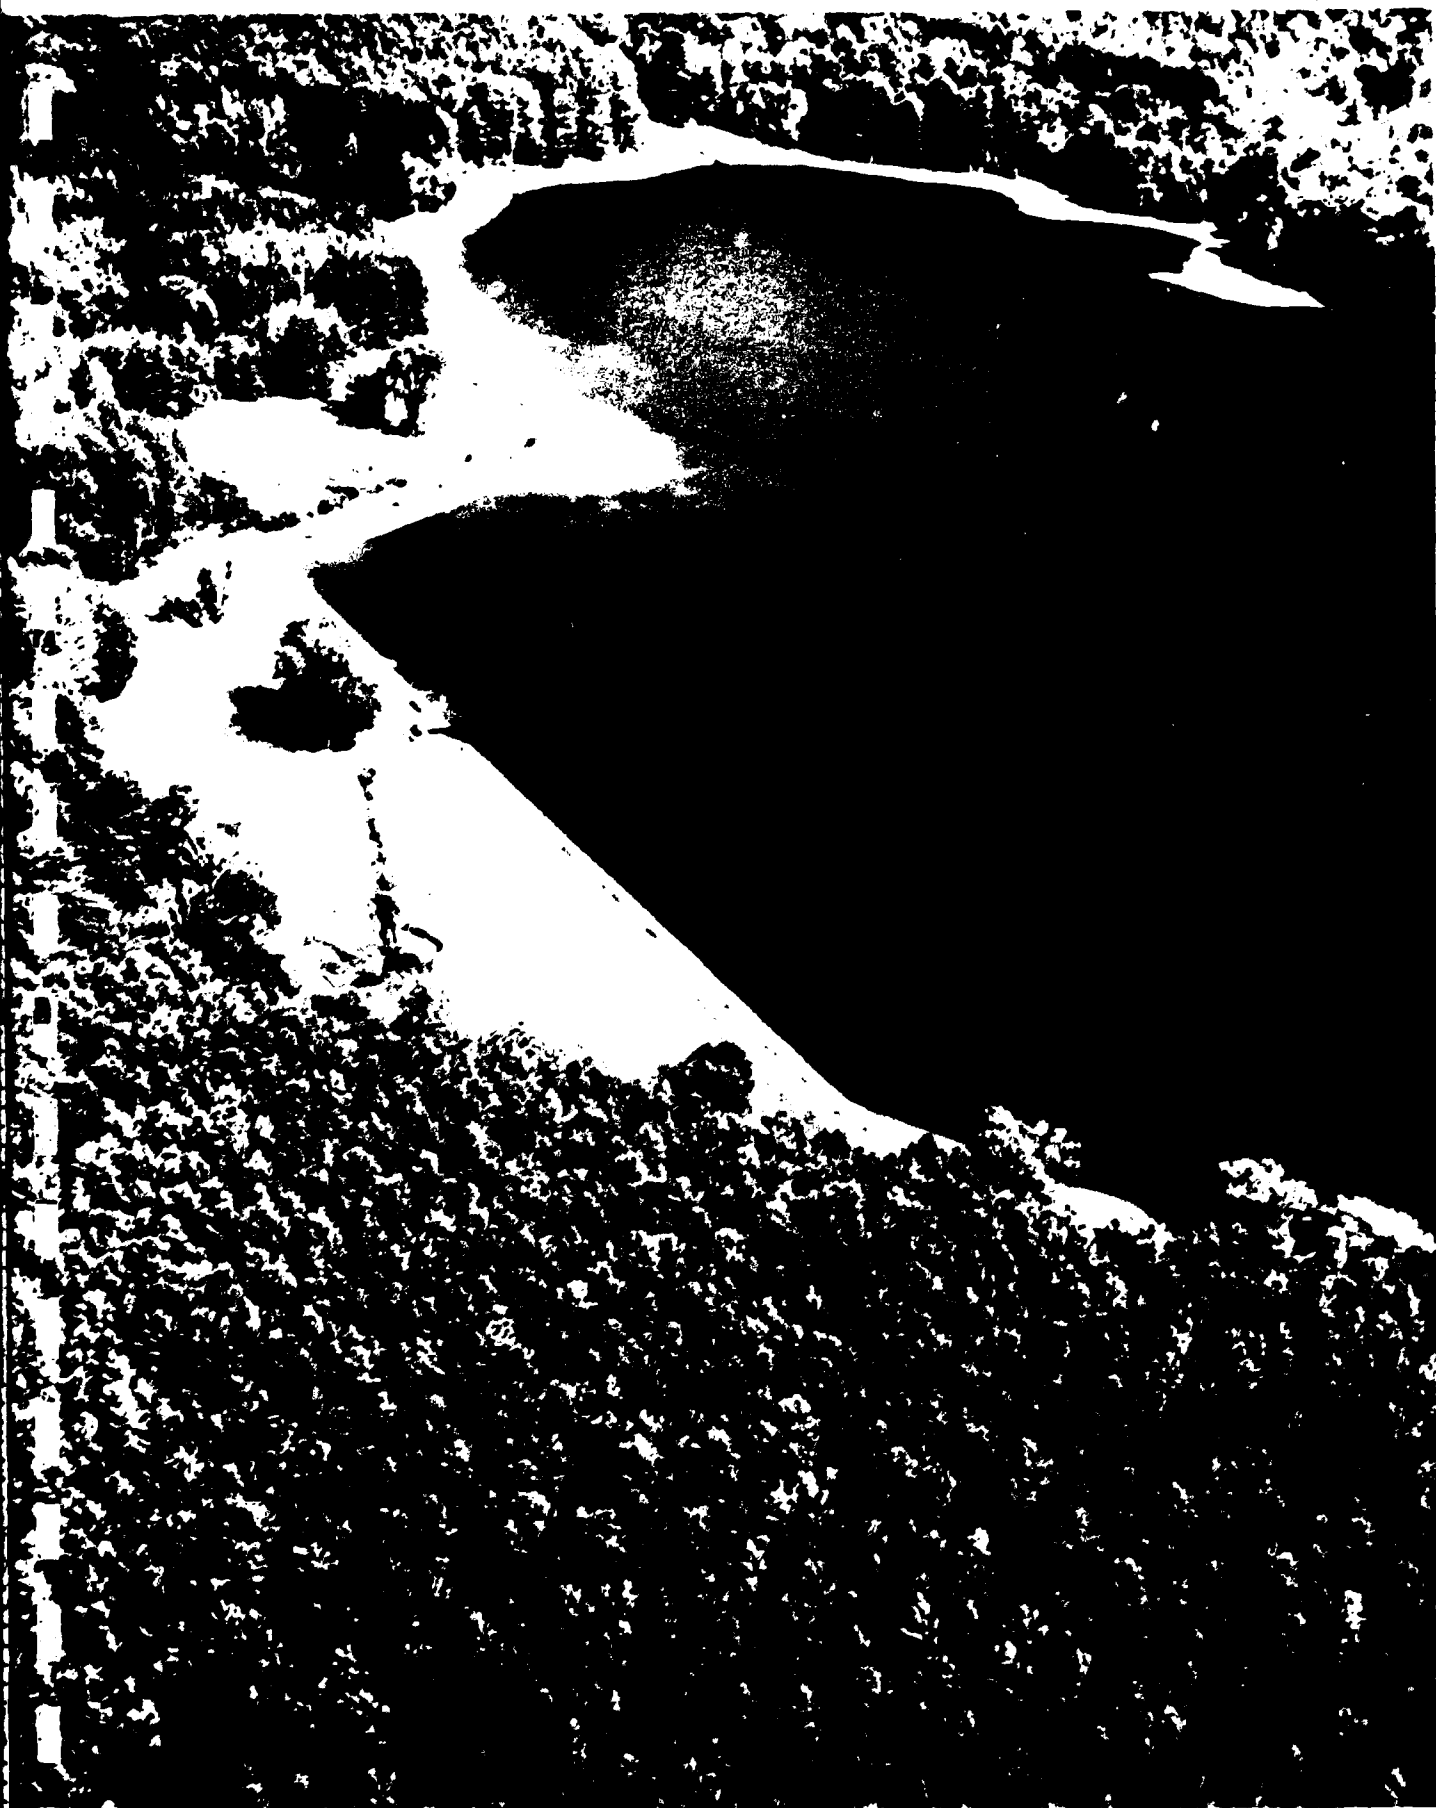
Upper Reservoir Dam - Overview from above left abutment

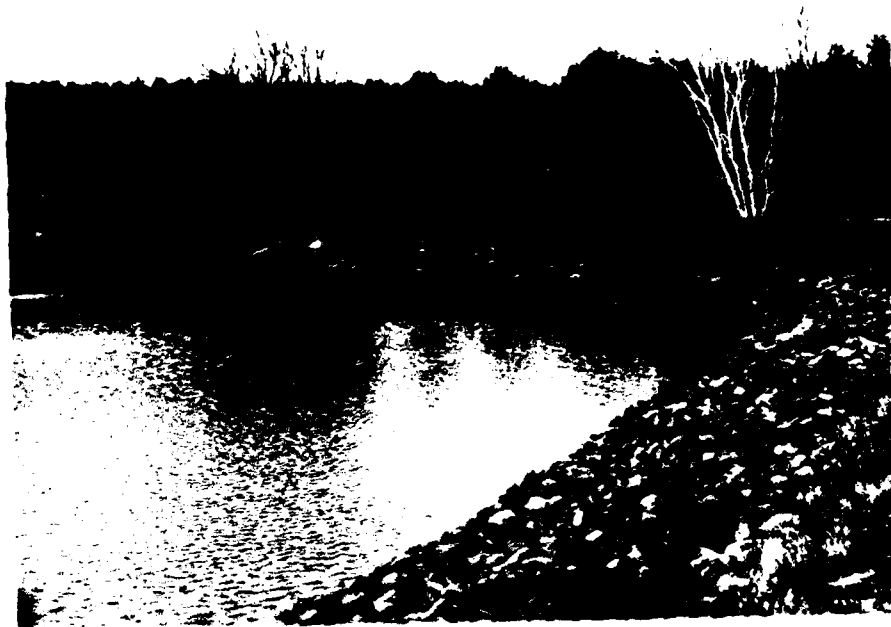
PHOTO NO. 2 - Upstream face as viewed from right end of dam.

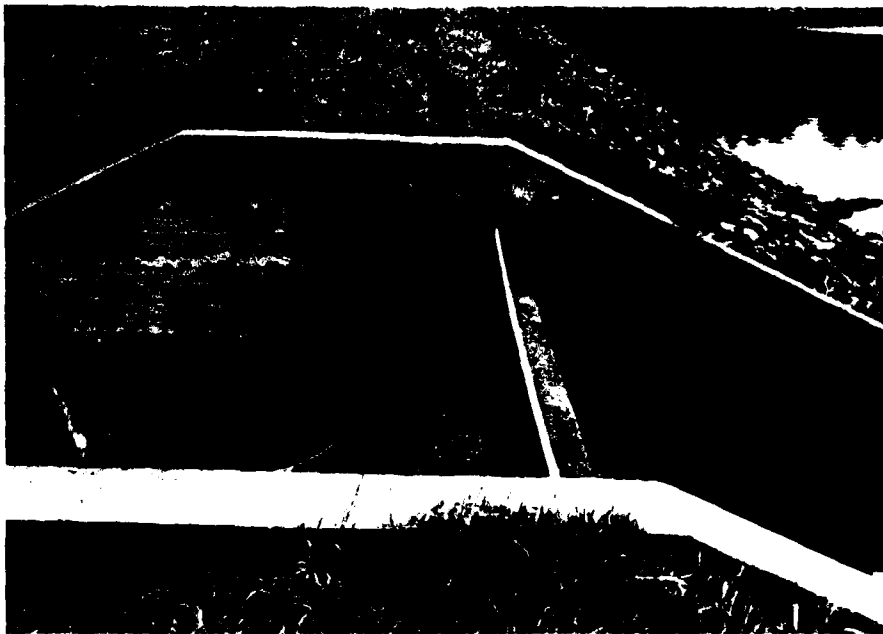
PHOTO NO. 10 - View of spillway weir crest.
